SUBJECT: Fuel Tank Vent Valve Noise

MODELS: E36 with M52 Engine

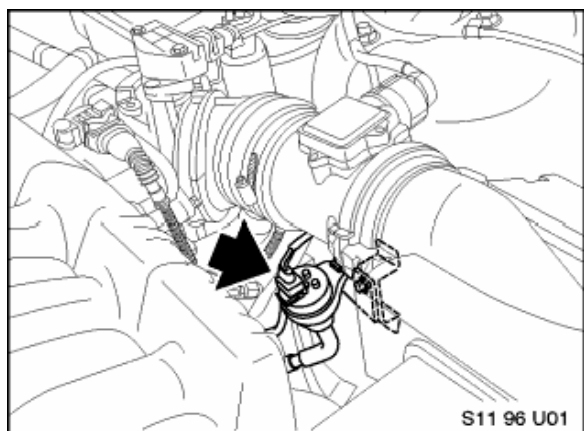
Cause: The fuel tank vent valve (TEV) located on the left front strut tower in the engine compartment, is transmitting normal operating noise through the body to the vehicles passenger compartment via the plastic mounting bracket and possibly the hose and tube routing to the bottom of the valve.

Remove the mounting bolt and fuel tank vent valve.
